Demonstration and Validation of Stainless Steel Materials for Critical Above-Grade Piping in Highly Corrosive Locations

Final Report on Project F07-AR15

Under Project F07-AR15, "Advanced Corrosion-Resistant Steel for Rehabilitation of
Fire-Suppression System Pipelines for Okinawa Fuel Tanks"

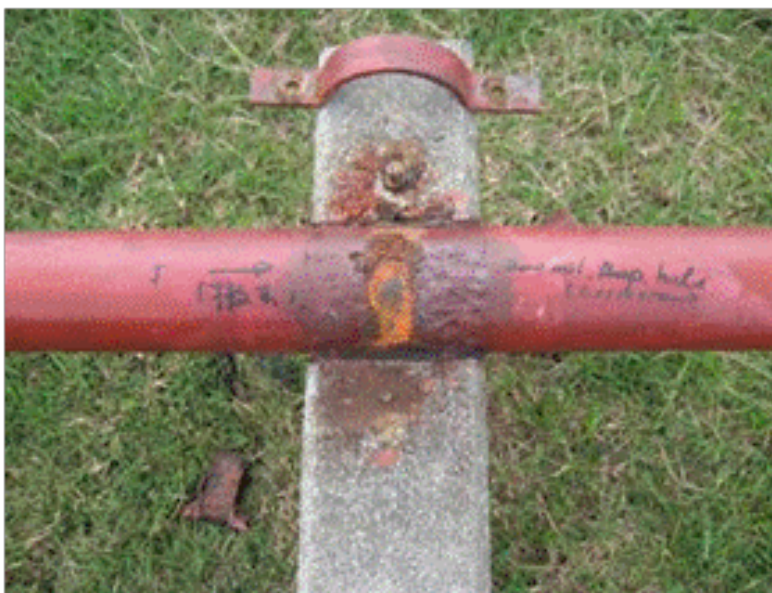
Figure 1. Severe corrosion at pipe support.

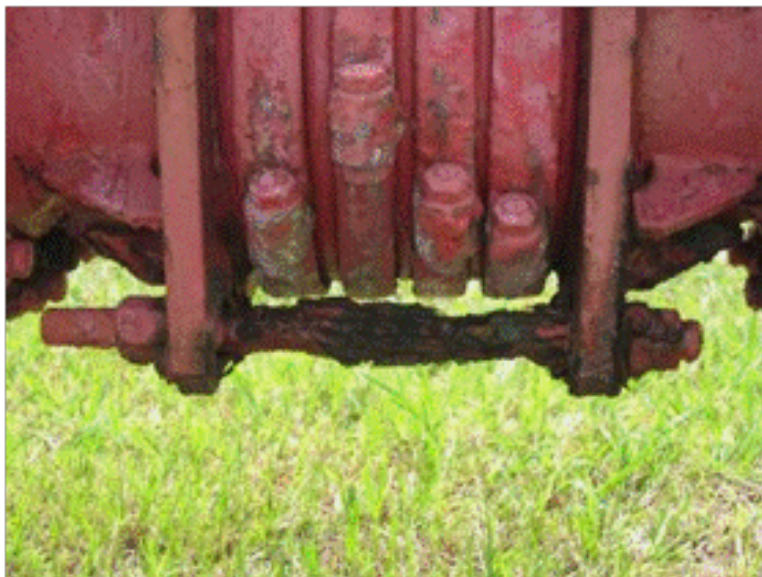
After meeting with QMBN and Directorate of Public Works (DPW) at Camp Courtney, inspections of the fire-protection pipelines were conducted at each of the three Chim-Wan bulk fuel tank farms. Within each tank farm, the fire protection pipelines were examined, noting areas of active corrosion. The piping within all three tank farms exhibited areas of significant corrosion activity and metal loss. The most significant corrosion was on the piping within Chimu-Wan 3 tank farm. Extensive corrosion was found along the bottom, at supports, risers, and valves of the above grade piping. Figure 1 shows severe corrosion at a pipe support, and Figure 2 shows a severely corroded flange bolt at a valve.

Figure 2. Severely corroded flange bolt

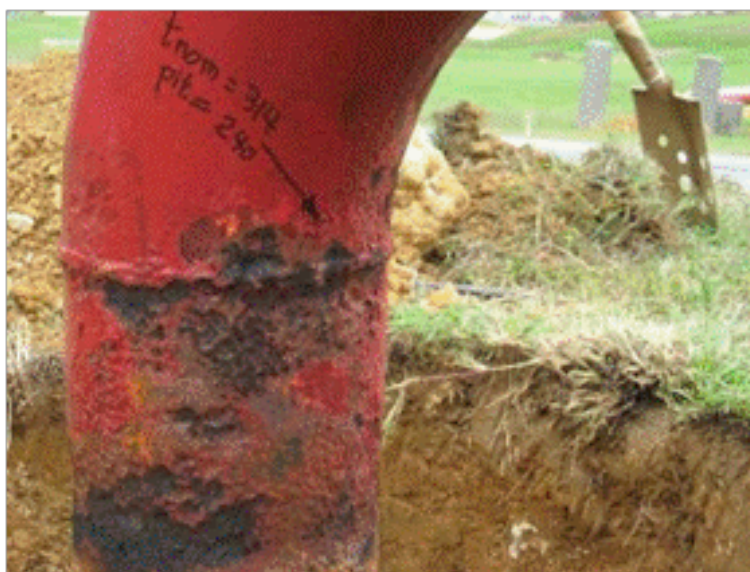
The underground fuel lines for each of the bulk fuel tank farms are coated and protected by impressed-current cathodic protection. The water lines are electrically grounded to the fuel lines, so they also benefit from the cathodic protection systems. Electro-chemical potentials were recorded where the underground water lines exit the soil. The measurements were recorded using a Fluke Model 179 voltmeter with a saturated copper/copper-sulfate reference cell. These data are presented in Appendix E. The data show that the underground water lines were effectively protected, meeting the NACE RP0285-2002 -850 mV instant-off criterion. The cathodic protection system only protects the below grade segments. The above-grade risers were severely pitted, as shown in Figure 3.

Figure 3. Severe pitting on above-grade riser.

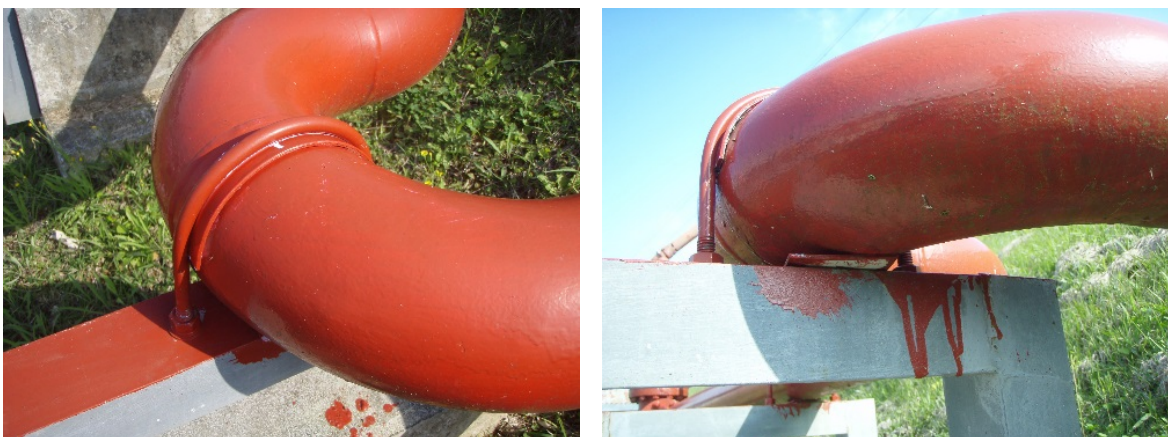
The replaced fire-suppression system pipes were visually inspected in March 2017 to evaluate the performance of the demonstrated technology. The inspection found all sections of the piping to be in good condition, with the replaced pipes and supports showing no significant corrosion damage. Figure 6 shows examples of spotting and running on pipe supports that indicate some recent touch-up recoating was done to a few sections of pipe. Installation records show that no contracted painting has been done on these areas since the installation, so it is likely that the touch-up work was done by DPW personnel or the tank farm operator.

Figure 6. Two sections of installed pipe showing evidence of touch up painting.

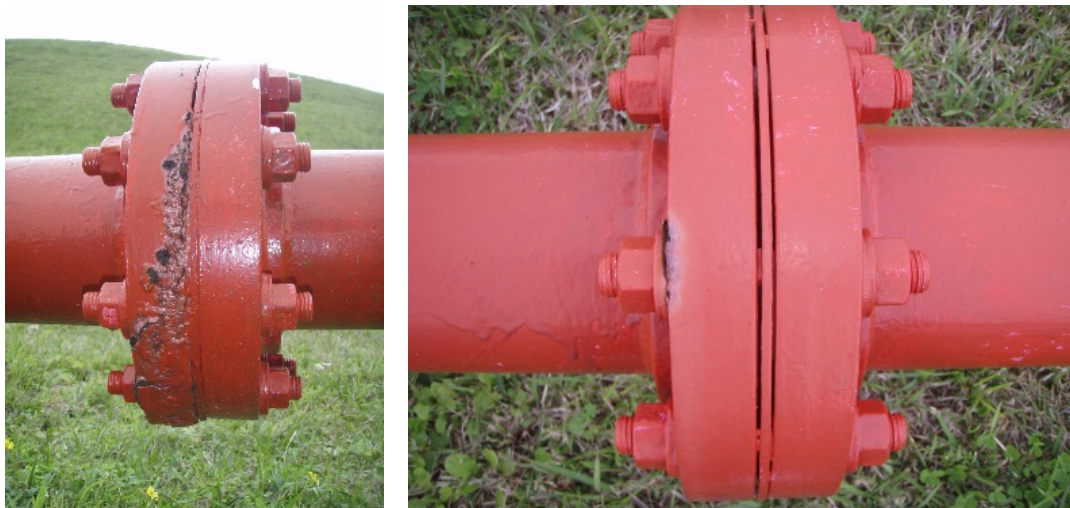
Photographs of the replaced pipe confirm that the overall condition is good. Some surface corrosion has occurred, mainly at flanges and bolted connections (Figure 7). These areas were not typical, and the level of corrosion is not considered significant. However, the inspection results confirm that periodic inspections and maintenance should be performed to clean and coat such areas.

Figure 7. Corrosion at a pipe flange (left) and bolted connection (right).

Based on the inspection report, the pipe appears to be performing as expected. Routine maintenance will be required to address the areas of surface corrosion. With proper maintenance (a \$5,000 annual maintenance budget is assumed in the cost analysis) this pipe should easily meet the expected 30 year useful life projected for this application.

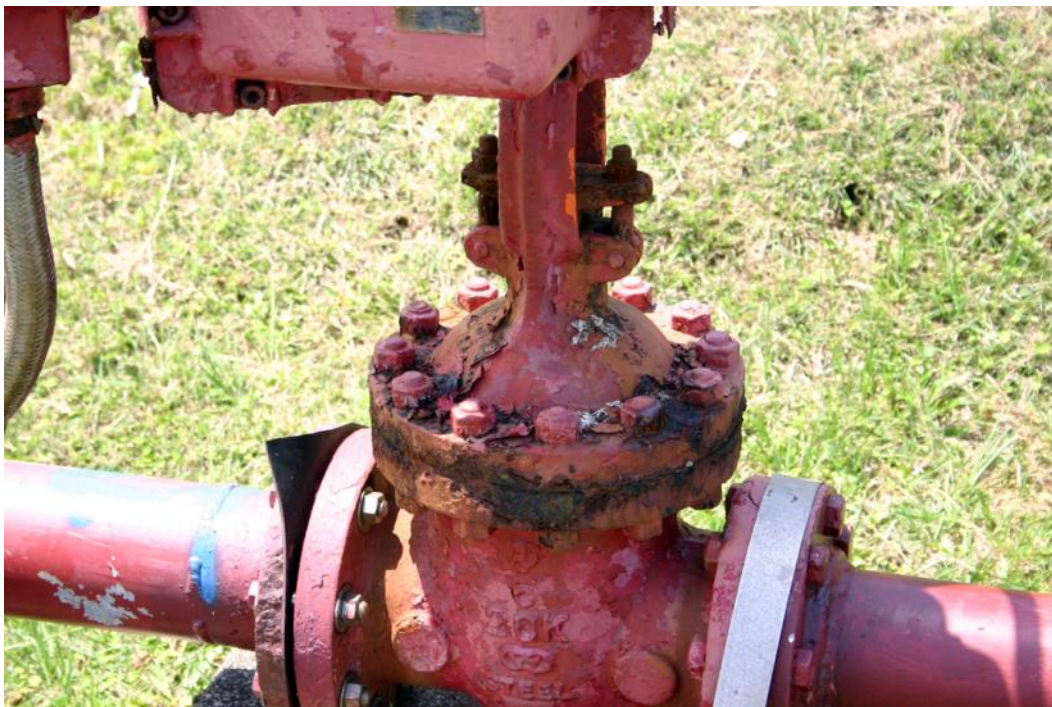
Figure B4. Photograph of one of the corrosion damaged valves that was replaced at the Chimyu-Wan Tanks Farm #3, Okinawa, Japan.

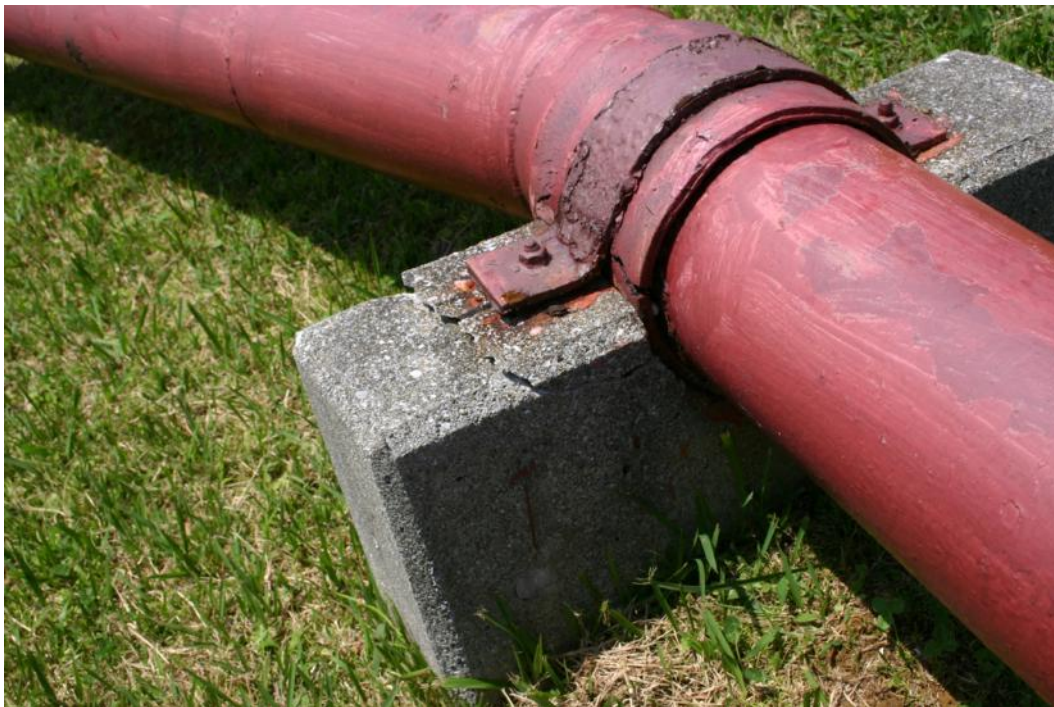
Figure B5. Photograph of the structural damage caused by corrosion of the pipe at the Chimyu-Wan Tank Farm #3, Okinawa, Japan.

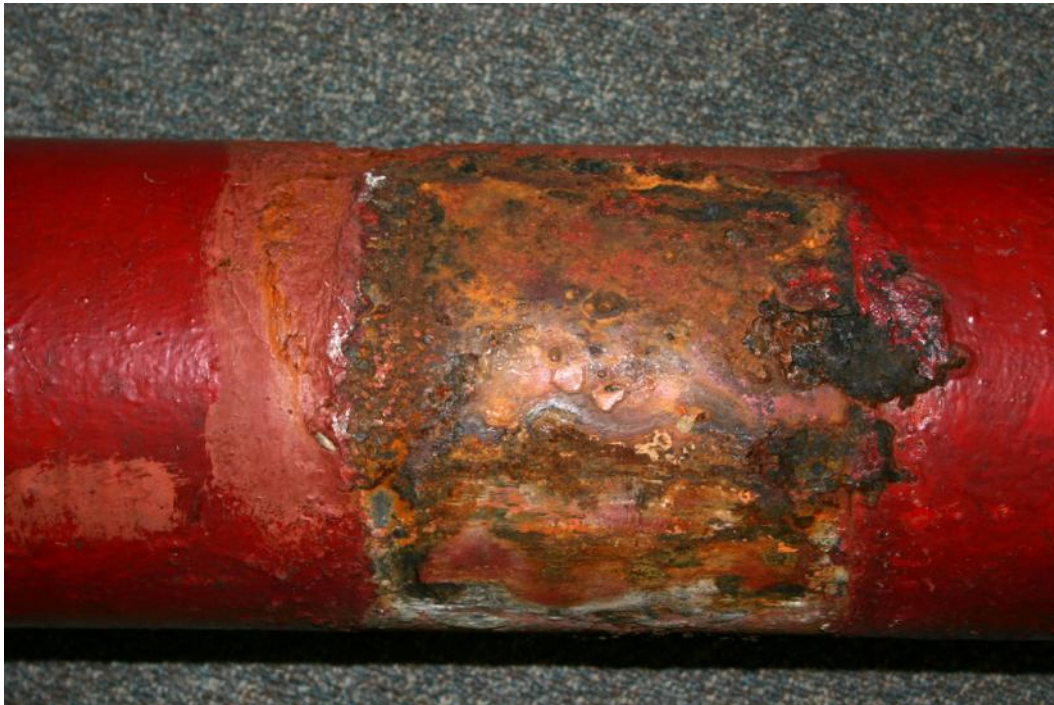
Figure B7. Photograph of the area of the pipe in contact with the concrete saddle in the field.

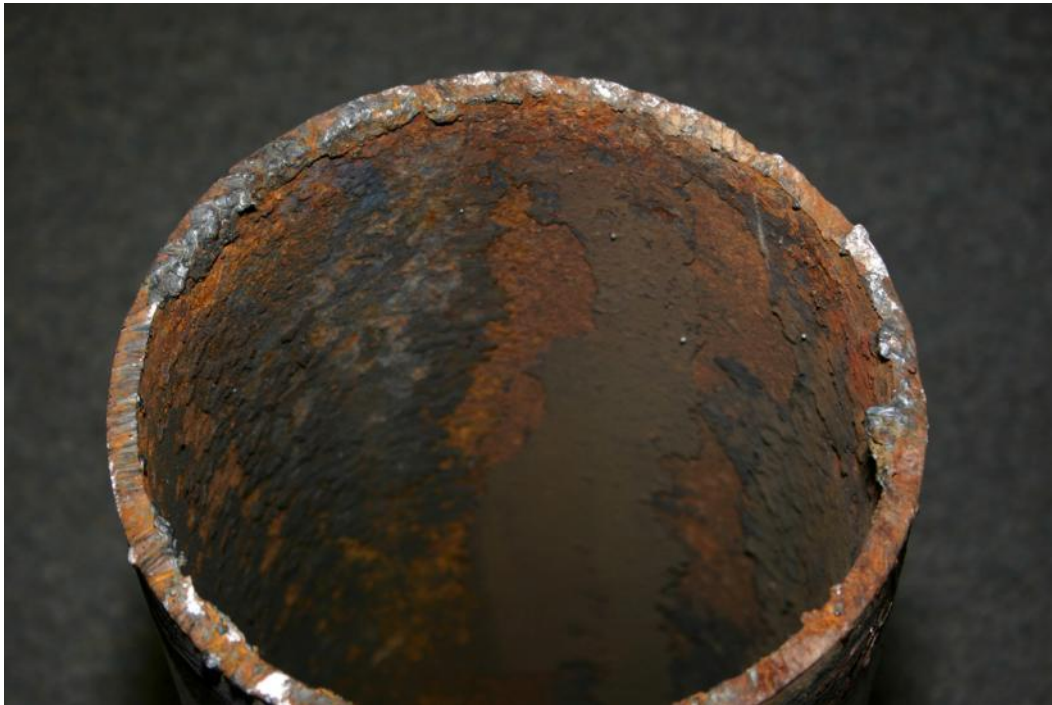
Figure B9. Photograph of the interior of the pipe as received from Okinawa showing light general corrosion.

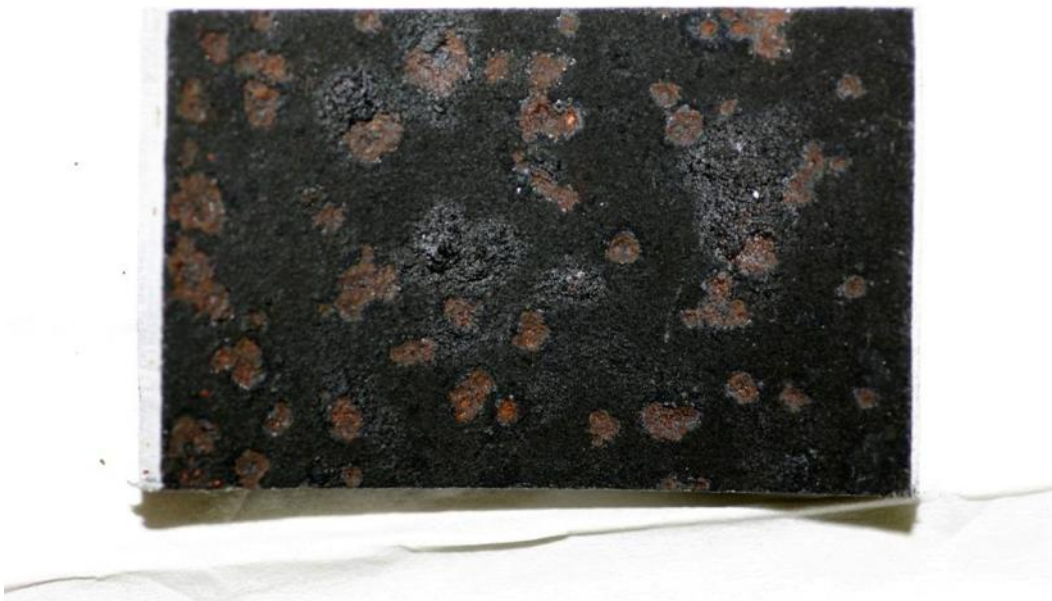
Figure B10. Photograph of the interior of the pipe showing the beginning of pitting corrosion from the water carried in the pipe.

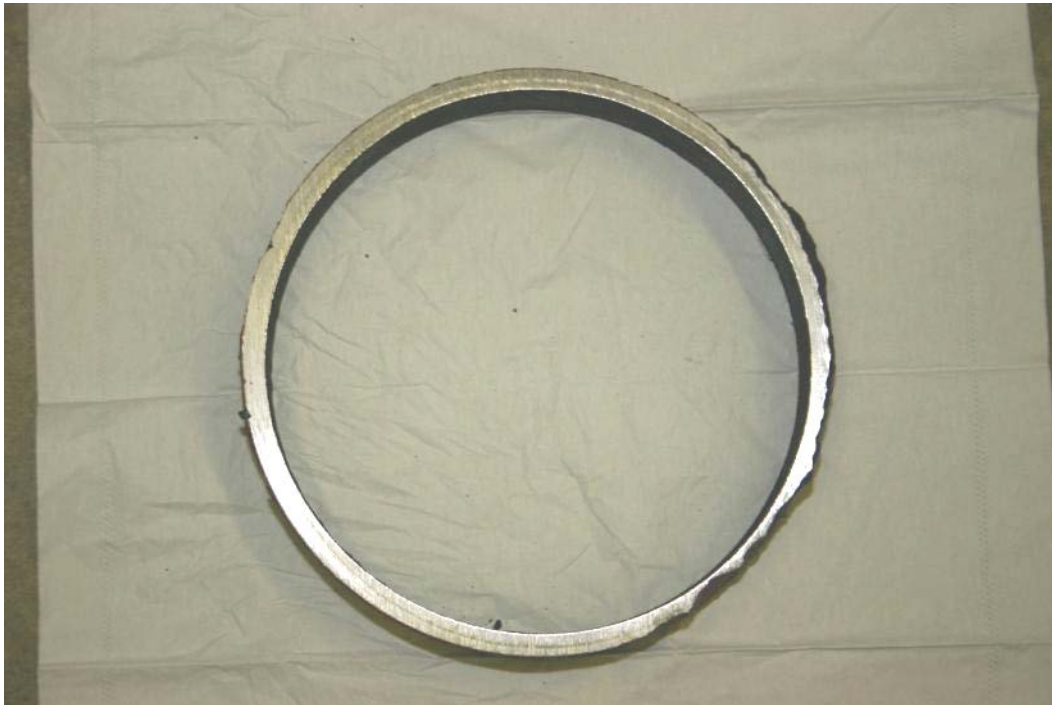
Figure B11. Photograph of the cross section of the pipe showing the wall thinning near the area of the support saddle.

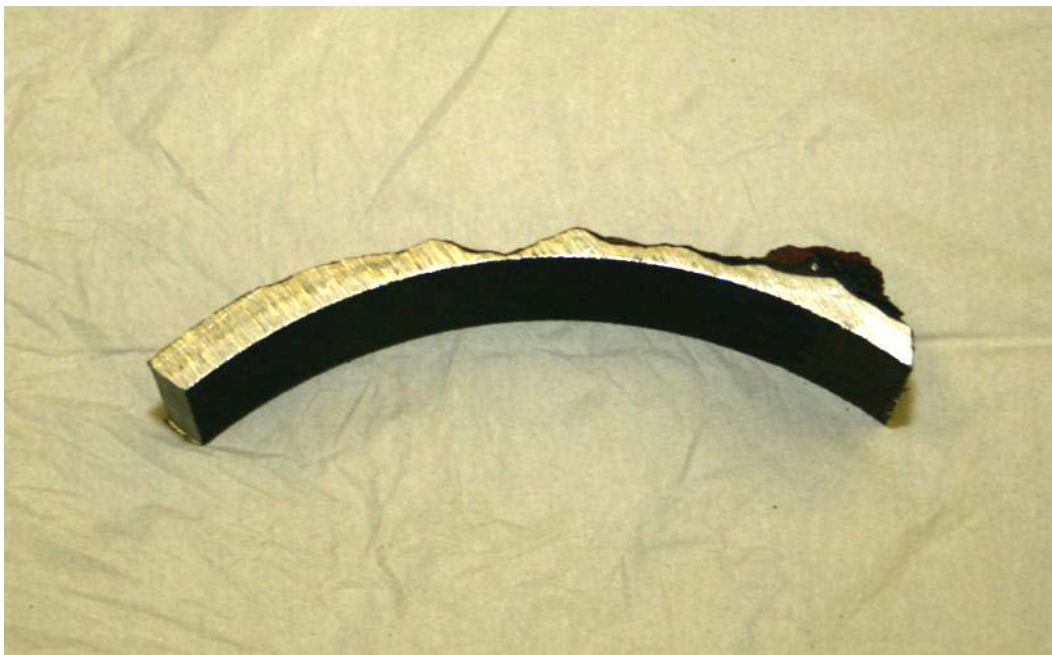
Figure B12. Photograph of the deeply corroded area on the outside of the pipe.

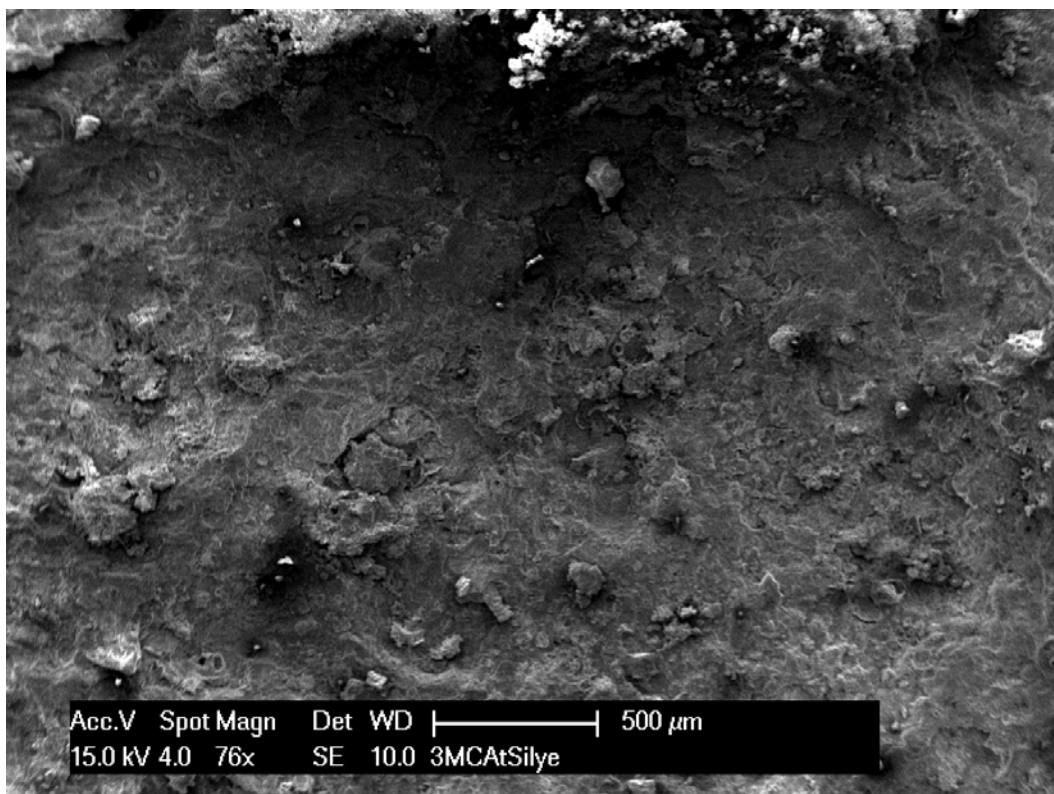
Figure B15. Photomicrograph of the interior surface of the pipe sample where corrosion had thinned the pipe wall. (76x)
